# Behaviour of Reinforced Concrete Deep Beams with Openings in the Shear Zone

8<sup>th</sup> MUCET 2014, Date: 10-11 November 2014, Melaka, Malaysia

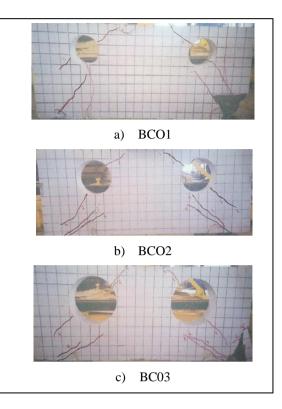
Crack patterns of RC deep beams with circular openings are depicted in Fig. 7. Fig. 7(a) shows the crack pattern of beam BCO1. It was observed that diagonal cracks were initially formed around the openings which then propagated towards the support and loading points, respectively. With a further increment of load, the cracks below the right opening propagated more towards the support which resulted in concrete cracking and spalling. Meanwhile, crack pattern in beam BCO2 showed two independent diagonal cracks at the top chord of both openings. Similarly, cracks were found propagated diagonally at the bottom of opening towards the support. With an increase in the load applied, new additional shear cracks were formed below the openings towards the support, as shown in Fig. 7(b). As illustrated in Fig. 7(c), the crack patterns of beam BCO3 were found almost similar as obtained in beam BCO2. However, the diagonal cracks at the bottom of the openings propagated towards the support were more severe than beam BCO2 which leads to crushing of concrete at the edge of the beam.

Fig. 7. Crack pattern of RC deep beams with circular openings (a) BCO1 (b) BCO2 (c) BCO3

- 3. Comparing in terms of shape, circular opening is the most suitable option to be provided in RC beams as square openings consists of sharp corners/edges which is subjected to high stress concentration that leads to initial cracking of the beam.
- 4. In terms of size, a significant reduction of beam capacity was obtained when the size of the square opening was increased from 150x150 mm to 250x250 mm, about two times the reduction of beam capacity in beam BSO1. Meanwhile, the increase in diameter of the circular opening from 150 mm to 250 mm exhibited a small reduction of strength, about 1.2 times of the losses in beam BCO1.

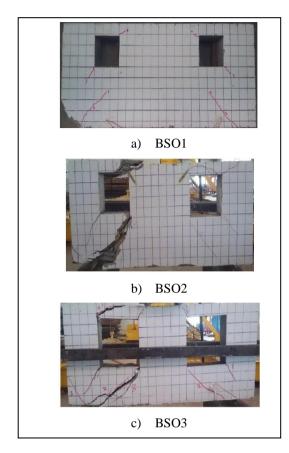
Fig. 8 illustrates the crack pattern of RC deep beams with square openings. Crack pattern of beam with square opening of size 150 x 150 mm is shown in Fig. 8(a). From the figure, it shows that diagonal cracks were initiated and formed at the corner of the openings; at the top near to the loading point and at the bottom near to the support, respectively. As the size of the opening increased to 200 x 200 mm, similarly, the cracks were formed at the corner near to the loading point and at the bottom corner near to the support in beam BSO2, as depicted in Fig. 8(b). Diagonal shear cracks were clearly seen at both corners at the bottom of the openings. With the increase of load, wide crack width was observed at the point of failure; at the top corner of the opening towards the loading point and at the bottom corner of the opening propagated towards the support. Similar as observed in beam BSO1 and BSO2, the crack pattern of BSO3 is rather severe with the opening size of 250 x 250 mm as shown in Fig. 8(c). Diagonal shear cracks were observed at the four corners of the opening; which penetrated from the top corner of the opening towards the loading points and from the bottom corners of the opening towards the support, respectively. The diagonal crack lines were apparent due to the increase in crack width at the top and bottom of the opening. The crack pattern is very much severe in beam BCO3 which due to a higher reduction of the concrete area.

Fig. 8. Crack pattern of RC deep beams with square openings (a) BSO1 (b) BSO2, (c) BSO3

cracks to be more severe. In this study, BSO3 exhibited the most severe cracks.
